Results of Review and Inspection of the Edelkind Property, Hull MA.
June 29, 2005

UNIFORM RESIDENTIAL APPRAISAL REPORT

Property Address	940 Nantasket Avenue			City	HULL		State	MA	Zip Code	02045
Legal Description	Please refer to Plymouth Registry of Deeds Book 19257 Page 118					County	PLYMOUTH			
Assessor's Parcel No.	Map 09 Lot 096			Tax Year 2005	R.E. Taxes \$	18,126	Special Assessments \$	None noted		
Borrower	N/A			Current Owner	Linda Edelkind		Occupant	Owner	Tenant	<input checked="" type="checkbox"/> Vacant
Property rights appraised	<input checked="" type="checkbox"/>	Fee Simple	Leasehold	Project Type	PUD	Condominium (HUD/V/A only) HOA\$ N/A /Mo.				
Neighborhood or Project Name	Allerton Hill			Map Reference MSA 14484			Census Tract 5001.01			
Sale Price \$	N/A	Date of Sale	N/A	Description and \$ amount of loan charges/concessions to be paid by seller						
Lender/Client	Lehman Brothers Bank			Address 10350 Park Meadows Drive Littleton, CO 80124						
Appraiser	Mary E. Granville MA CERT GEN #345			Address 150 Wood Road/Suite 1001, Braintree, Massachusetts 02184

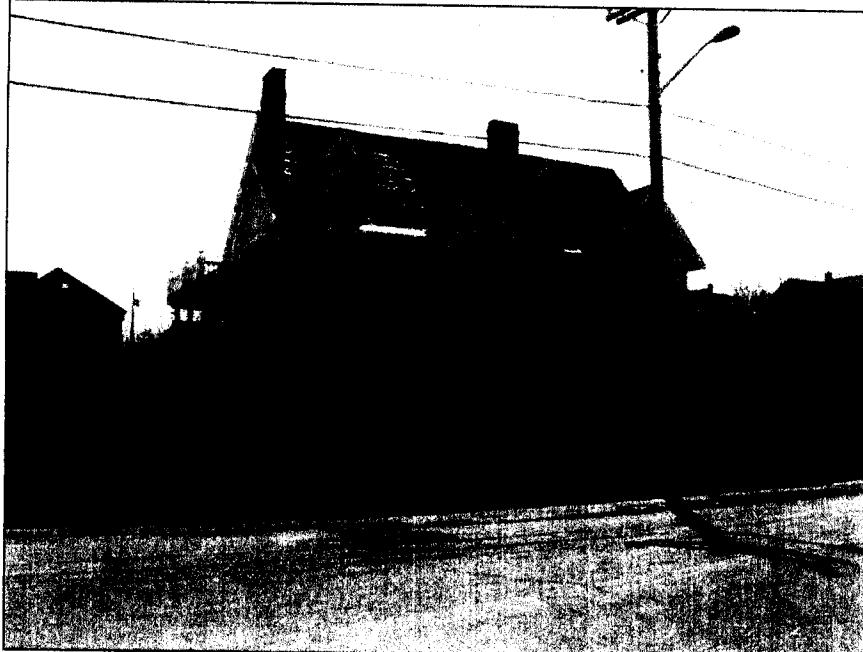
FRONT OF
SUBJECT PROPERTY

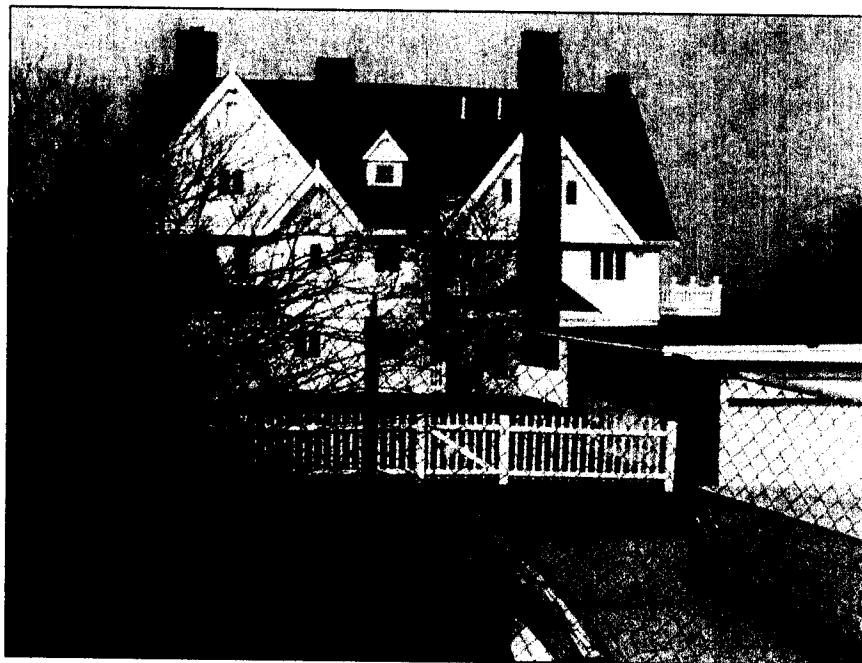
REAR OF
SUBJECT PROPERTY

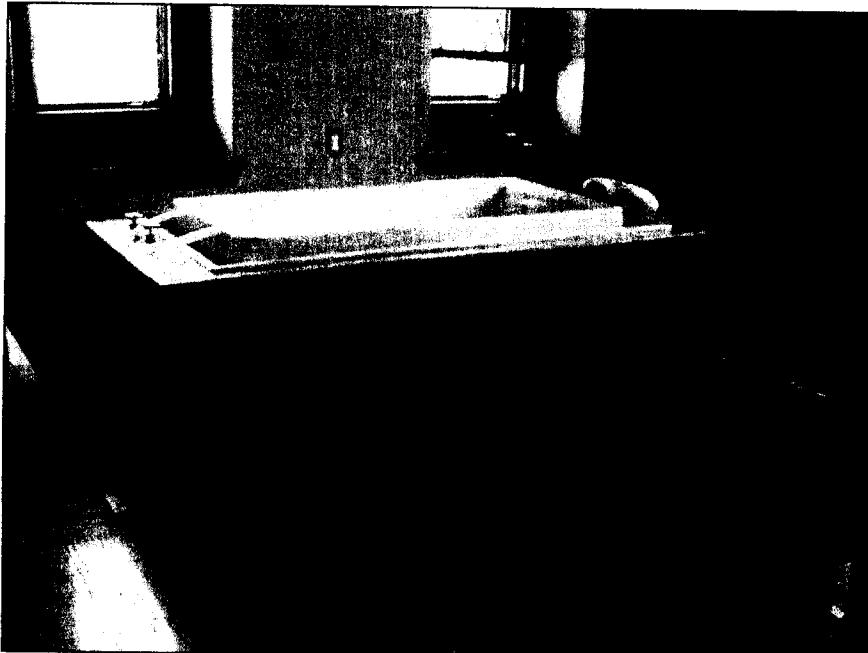
Master bedroom

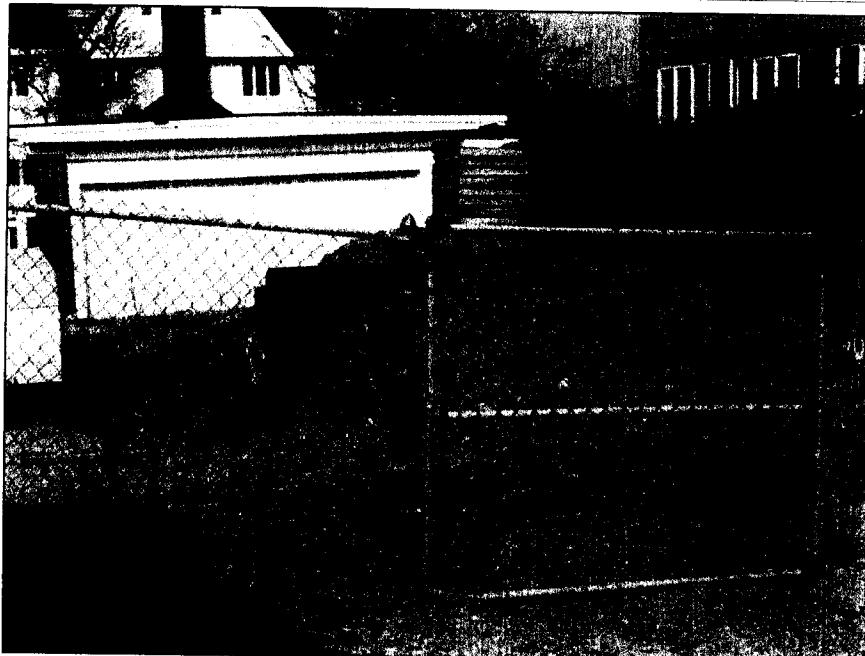
garage

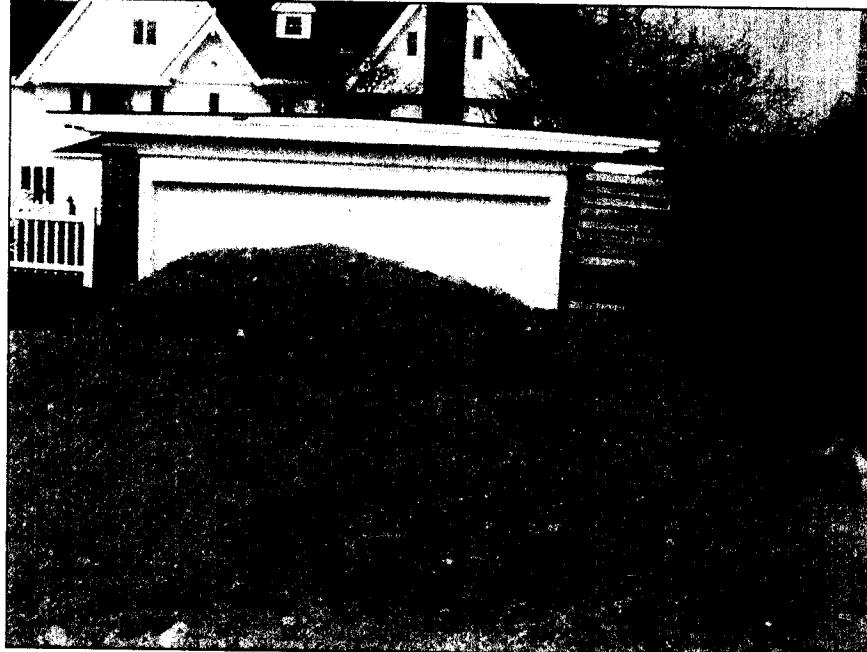
garage/old driveway
